Futuro no. 001 –

documentation and evaluation of preservation needs

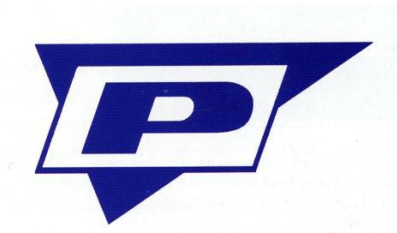
Figure 6. The sign of Polykem Ltd. (Home & Taanila 2004)

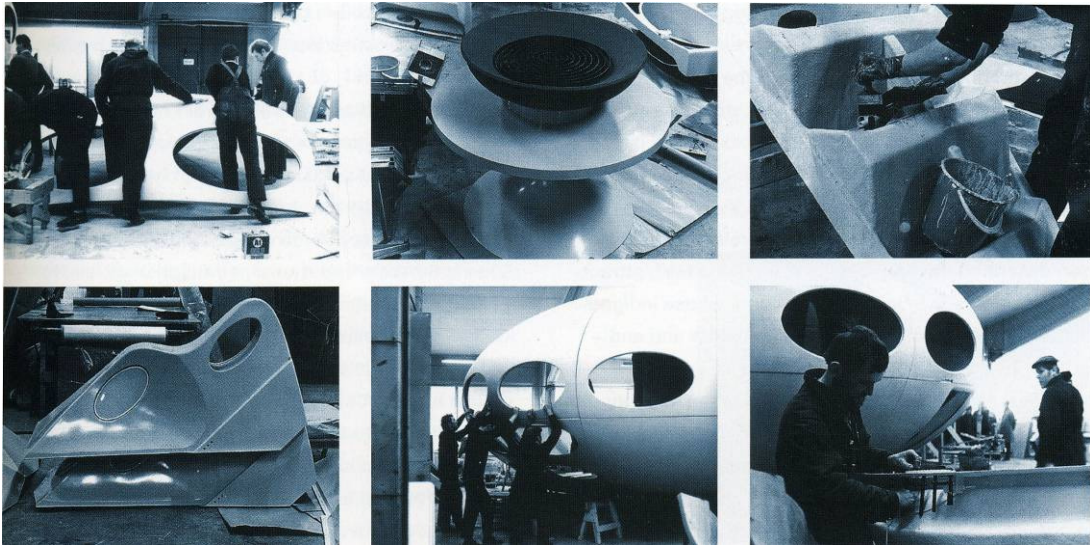
Figure 7. Assembly and finishing of the Futuro house at the factory of Polykem Ltd. (Home & Taanila 2004)

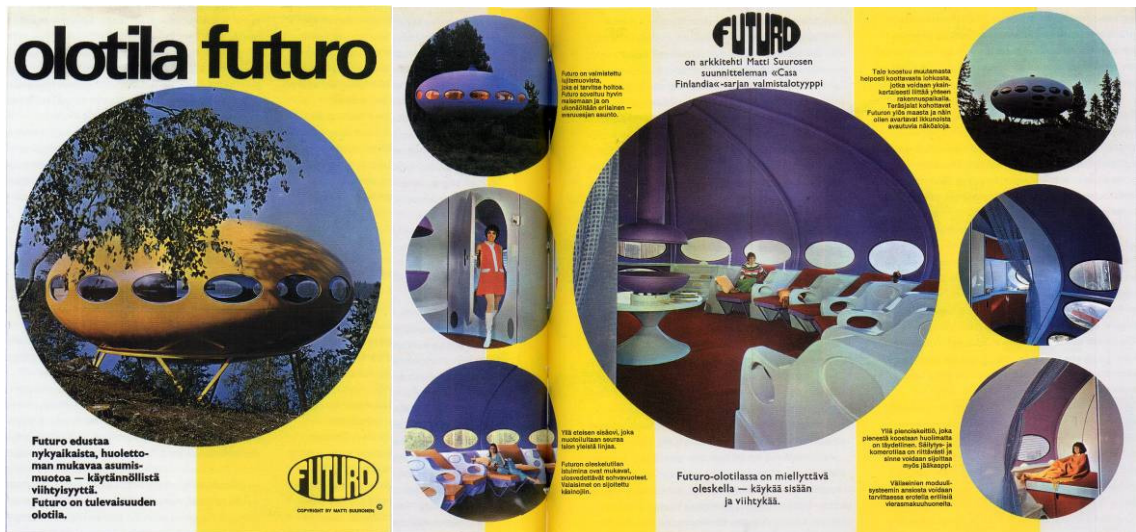
Figure 8. In the front page of the brochure can be seen Futuro no. 001 in Hirvensalmi spot. Interior pictures are probably from the prototype (no. 000). (Home & Taanila 2004)

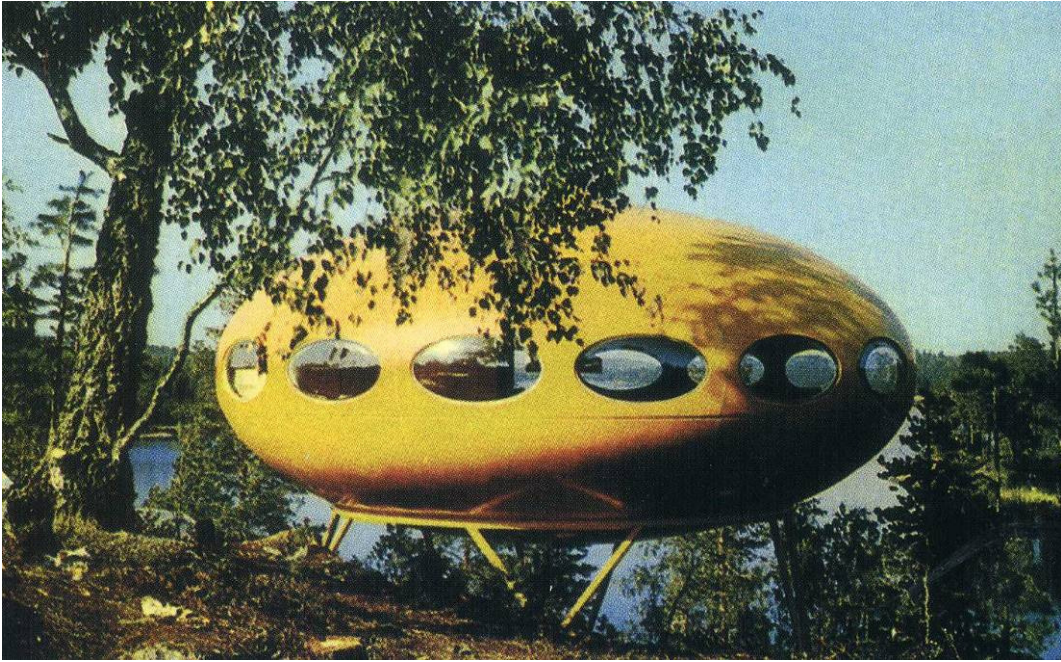
Figure 21. Futuro house stands close to the lake on a steep slope. Trees were cut down by the time of assembly in 1968. (Home & Taanila 2004)

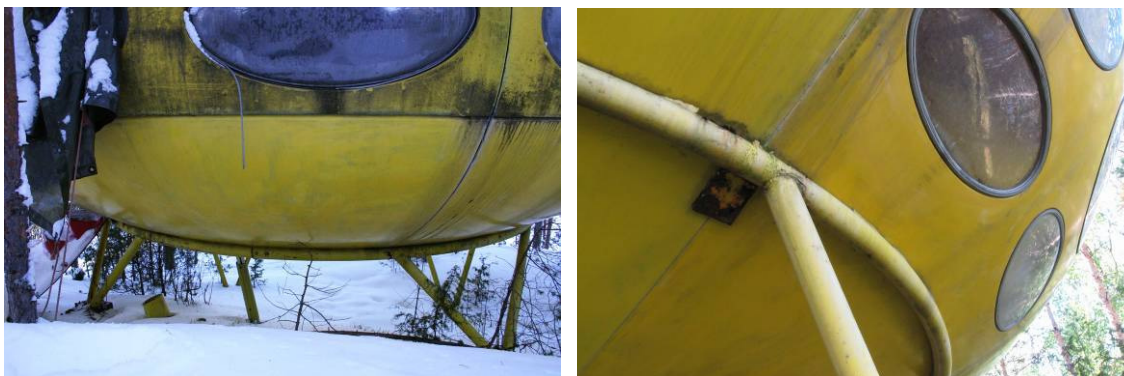
Figure 35. (left) Tubular steel legs.

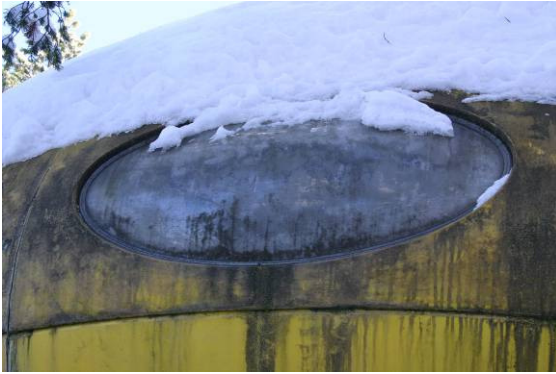
Figure 46. Window from the outside.

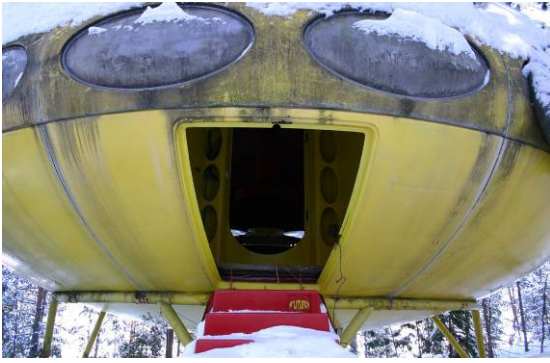
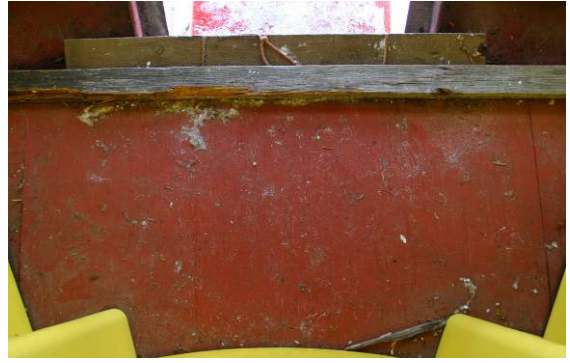
Figure 50. The entrance door transforms stairs. Figure 51. Entrance hall floor.

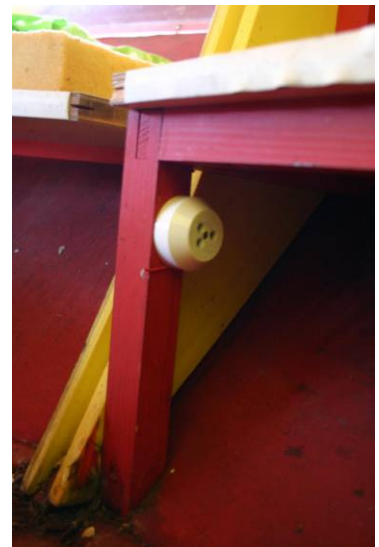
Figure 87. Socket for telephone.

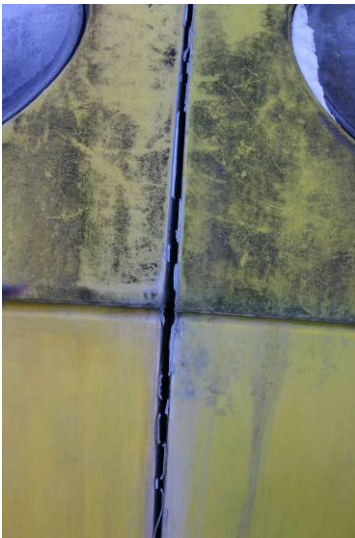
Figure 88. Many gaskets are cracked.

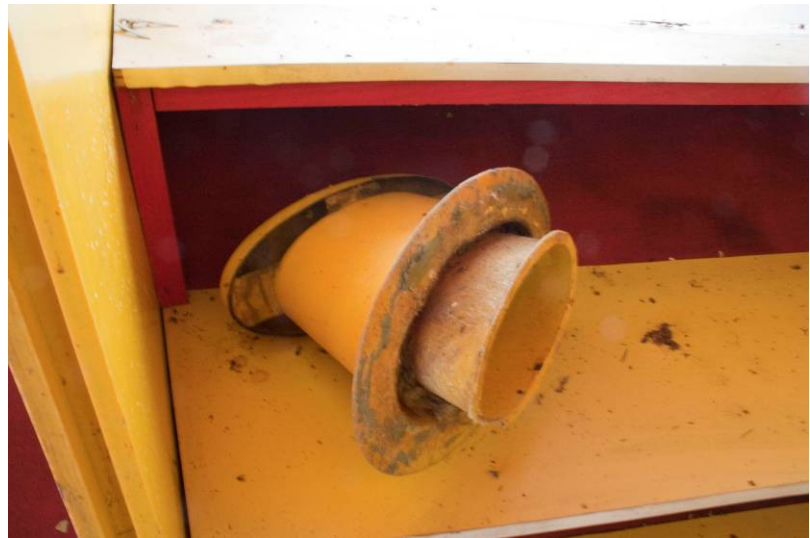
Figure 89. Protective cap of the air outlet has fallen down from the roof.

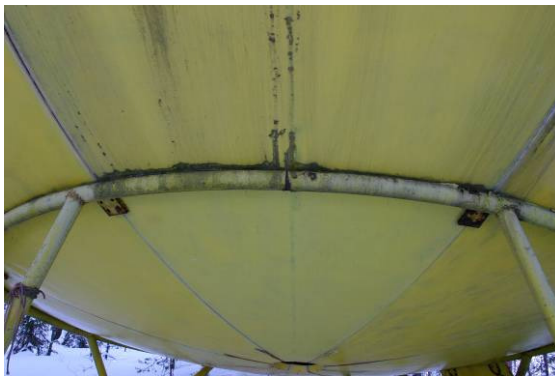
Figure 90. Steel ring is dirty and paint layer is coming off.

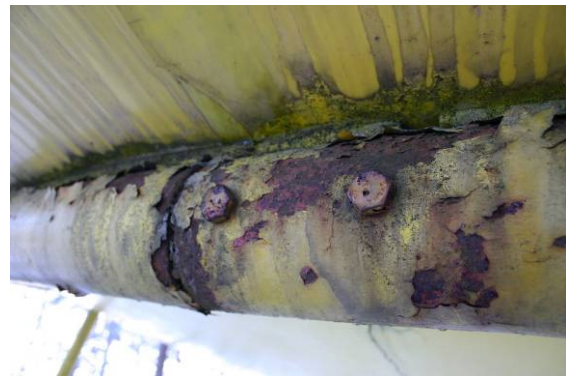
Figure 91. Corroded steel ring.

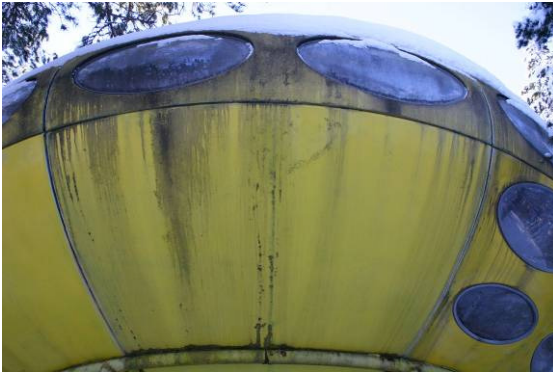
Figure 92. Dirt is concentrated mainly around the windows.

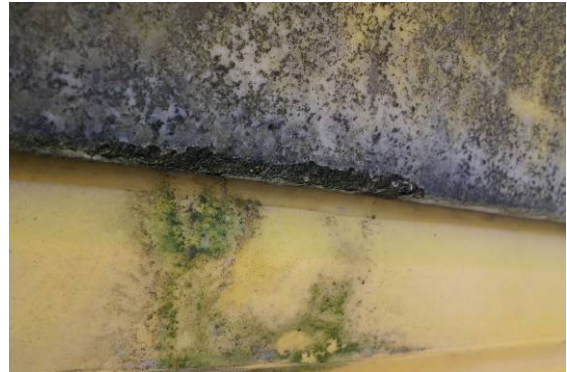
Figure 93. The edge of the small shelter has worn away. Some micro-organism was detected.

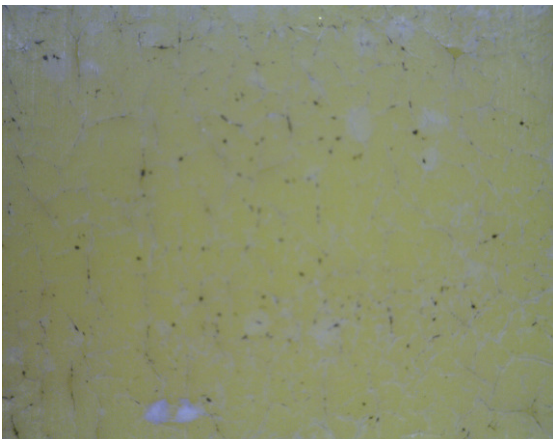
Figure 94. (left) The exterior wall surface has lost its gloss and become non-translucent. Fine cracks shows. (60-fold magnification)

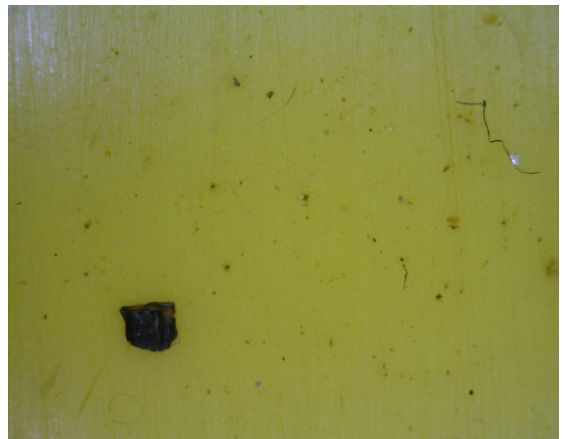
Figure 95. (right) The surface of the partition wall element is still glossy and in good condition. Only some small particles of dirt are present. (60-fold magnification)

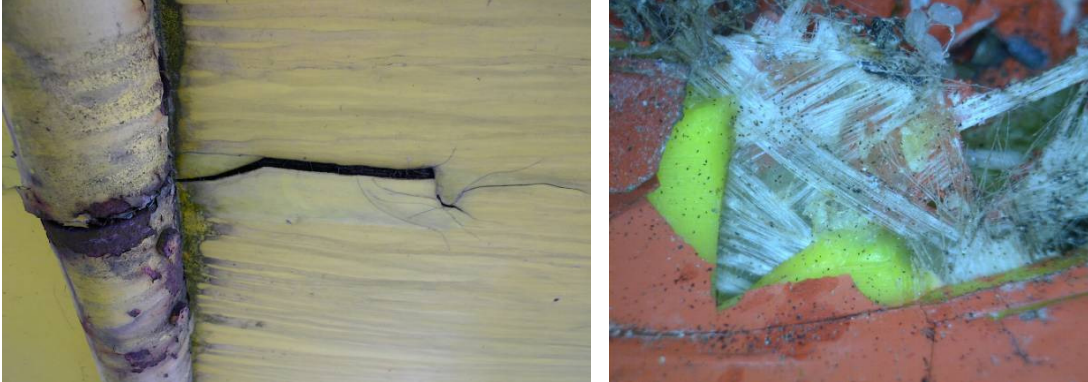
Figure 96. (left) Crack on the gel-coat on the bottom of the house.

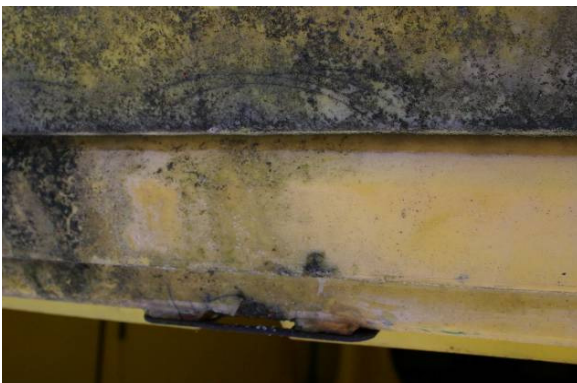
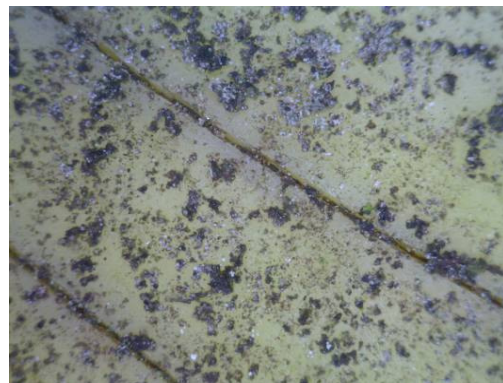
Figure 98. Some cracks are visible above the door.

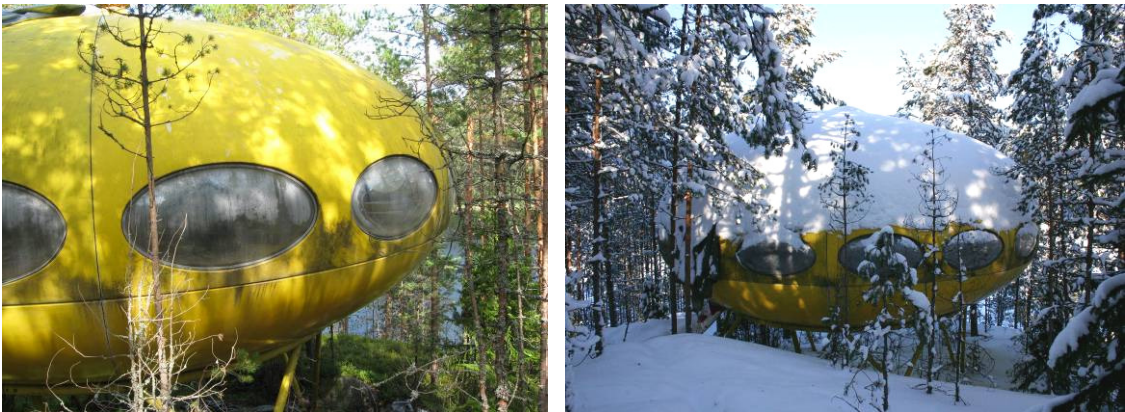
Figure 100. (left) A photograph taken in September 2009 shows the roof condition.
Figure 101. (right) Snow covers the roof.

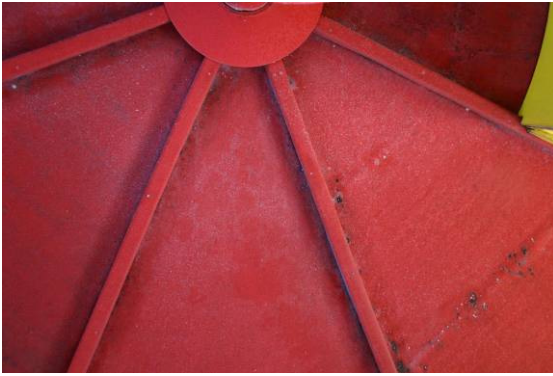
Figure 102. Some elevated areas on the living room ceiling and black deposit.

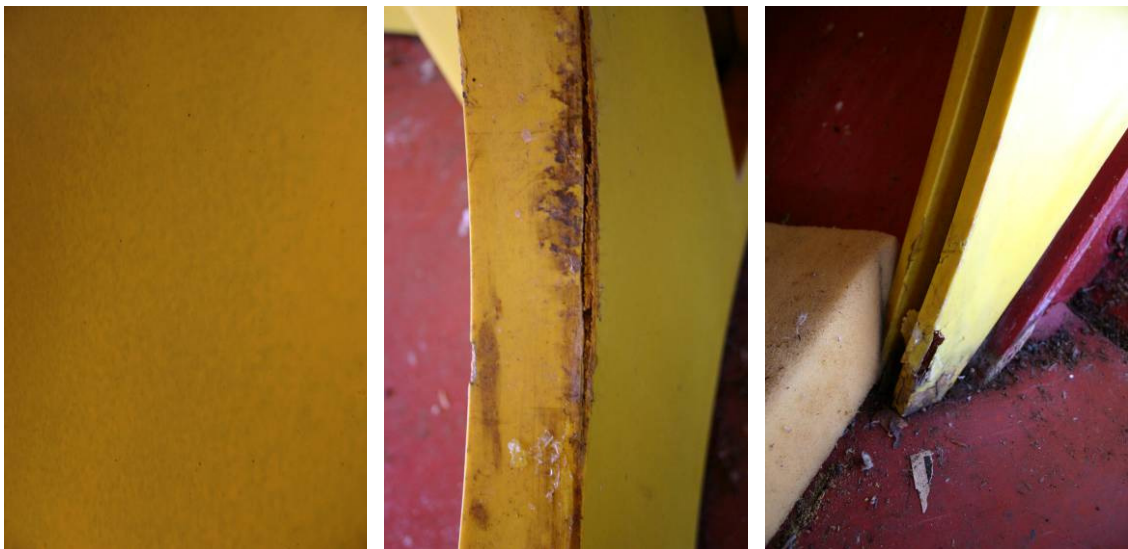
Figure 108. (left) Gel-coat layer is becoming thinner.

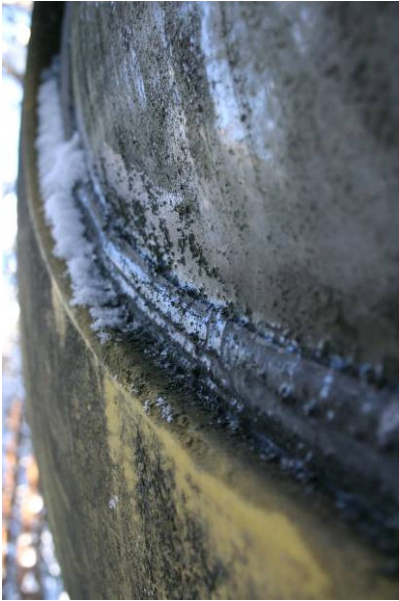
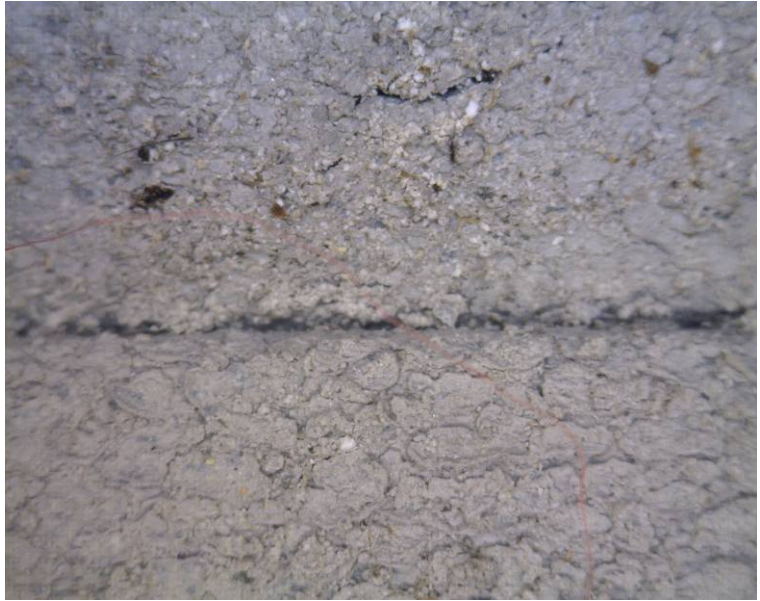
Figure 111. Ice on the window seal. Figure 112. Window seal surface has altered from smooth to uneven. (60-fold magnification)

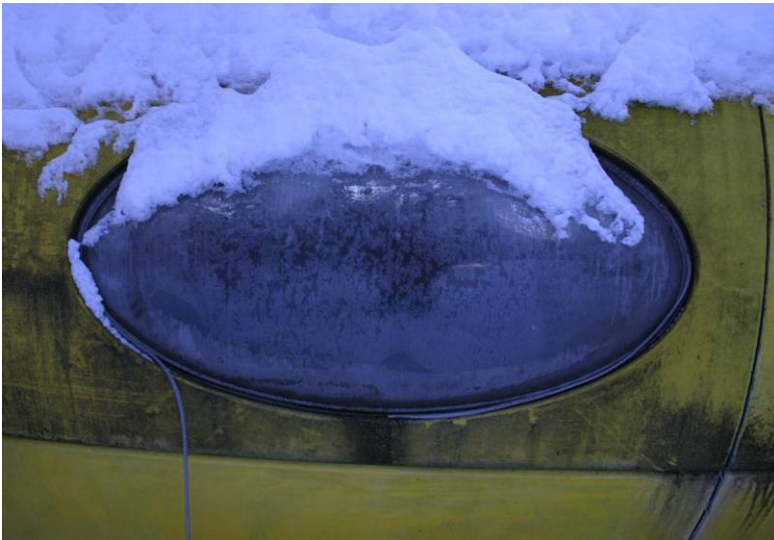
Figure 113. Window seal is loose.

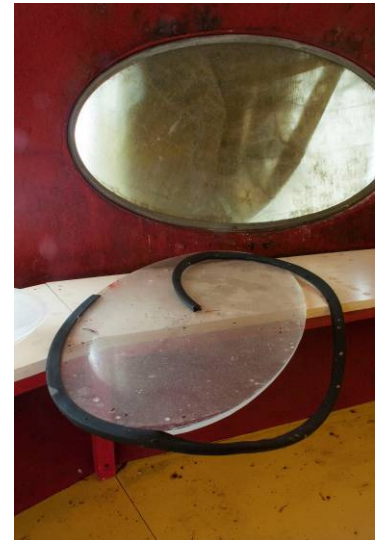
Figure 114. Fire-safety window.

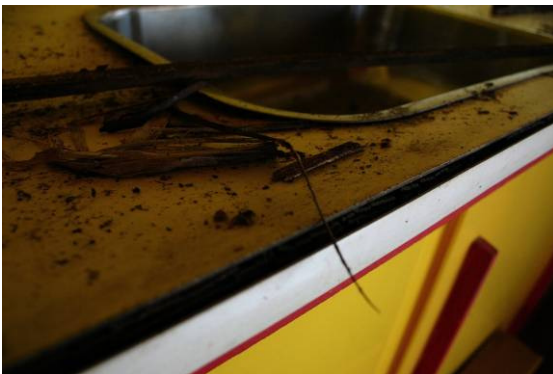
Figure 115. Loose edging strip.

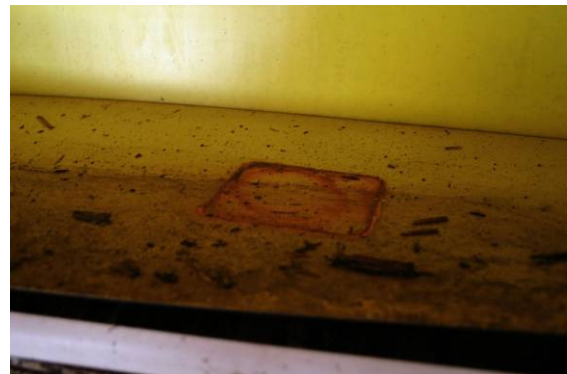
Figure 116. Rusty stains on the surface of the shelf.

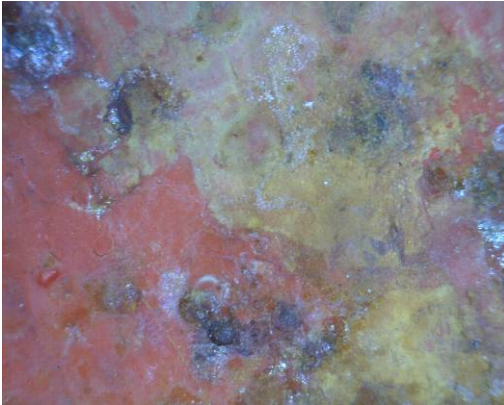
Figure 117. The yellow paint layer under the red paint layer of the steel hood of the fireplace. (200-fold magnification)

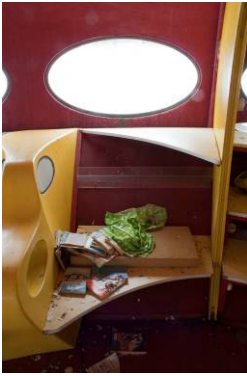
Figure 117. (left) Cushion on top of the shelf in the living room.

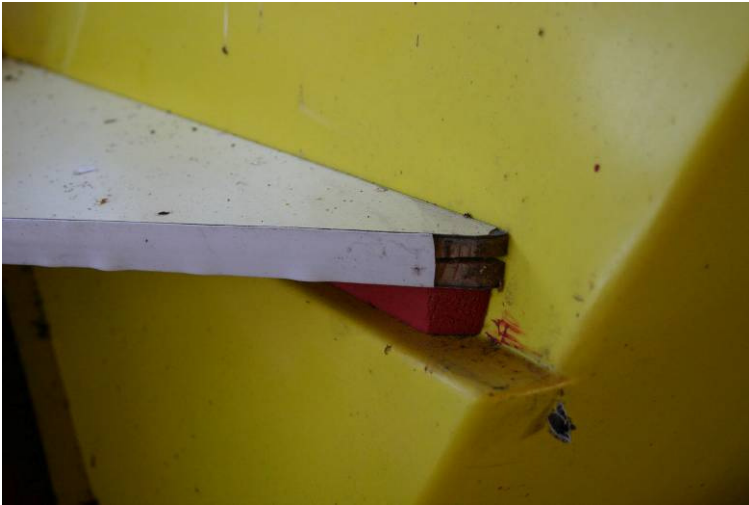
Figure 120. Missing part of the edging strip.

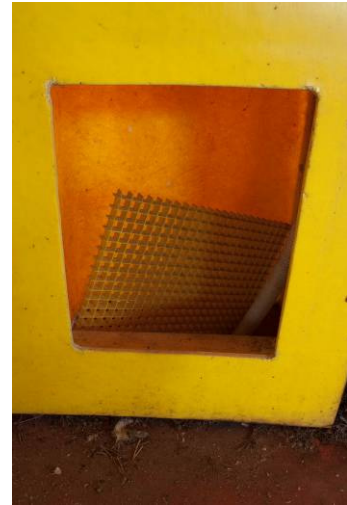
Figure 121. Loose grating on the ventilation hole.

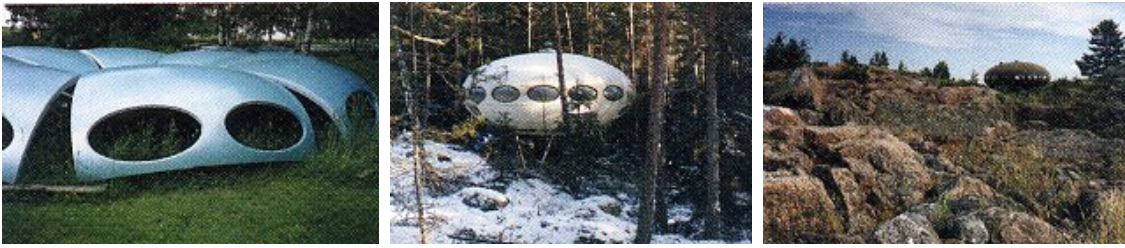
Figure 122. (left) Picture from Kauhava Futuro before it was assembled. (Home & Taanila 2004)

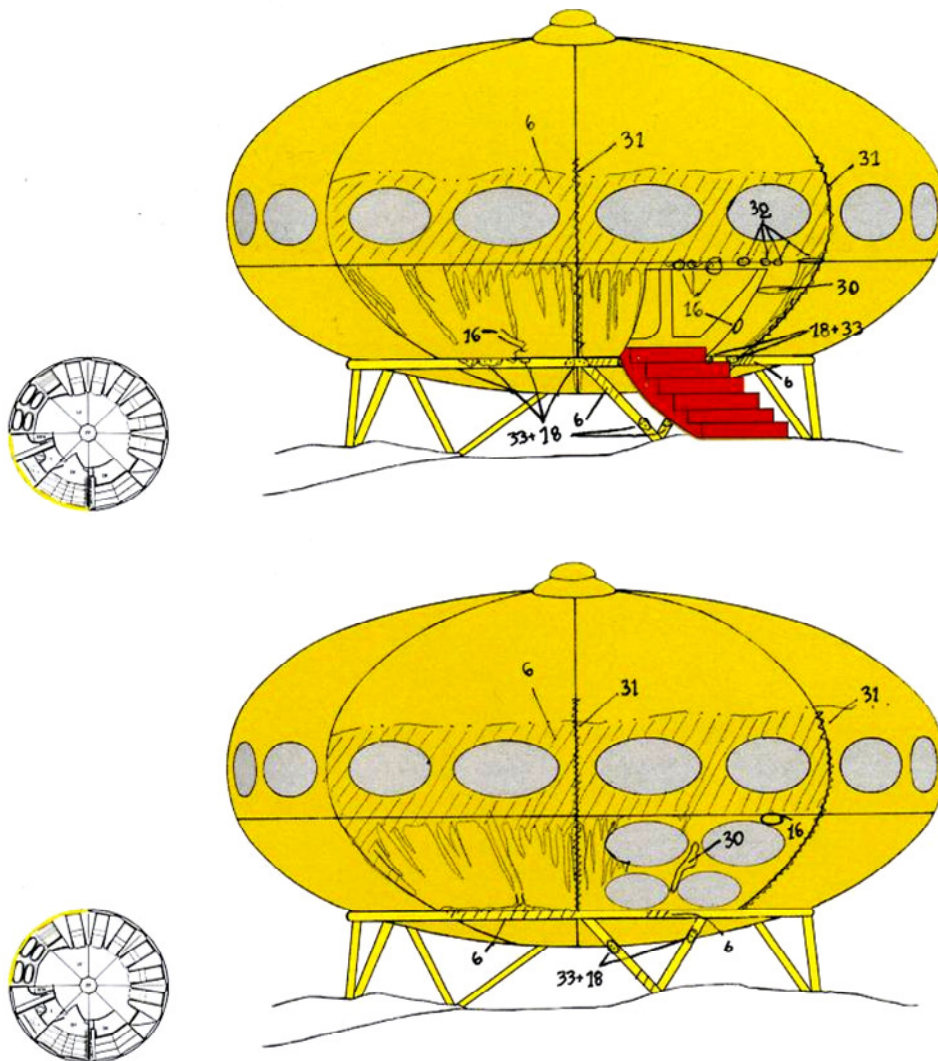
3	Whitish gloom	32	Fracture
6	Black deposit	33	Paint coming off
16	Crack	34	Loose window seal
18	Corroded	35	Missing rubber band
30	Gel-coat become thinner	36	Crumbled plastic foam band
31	Gasket

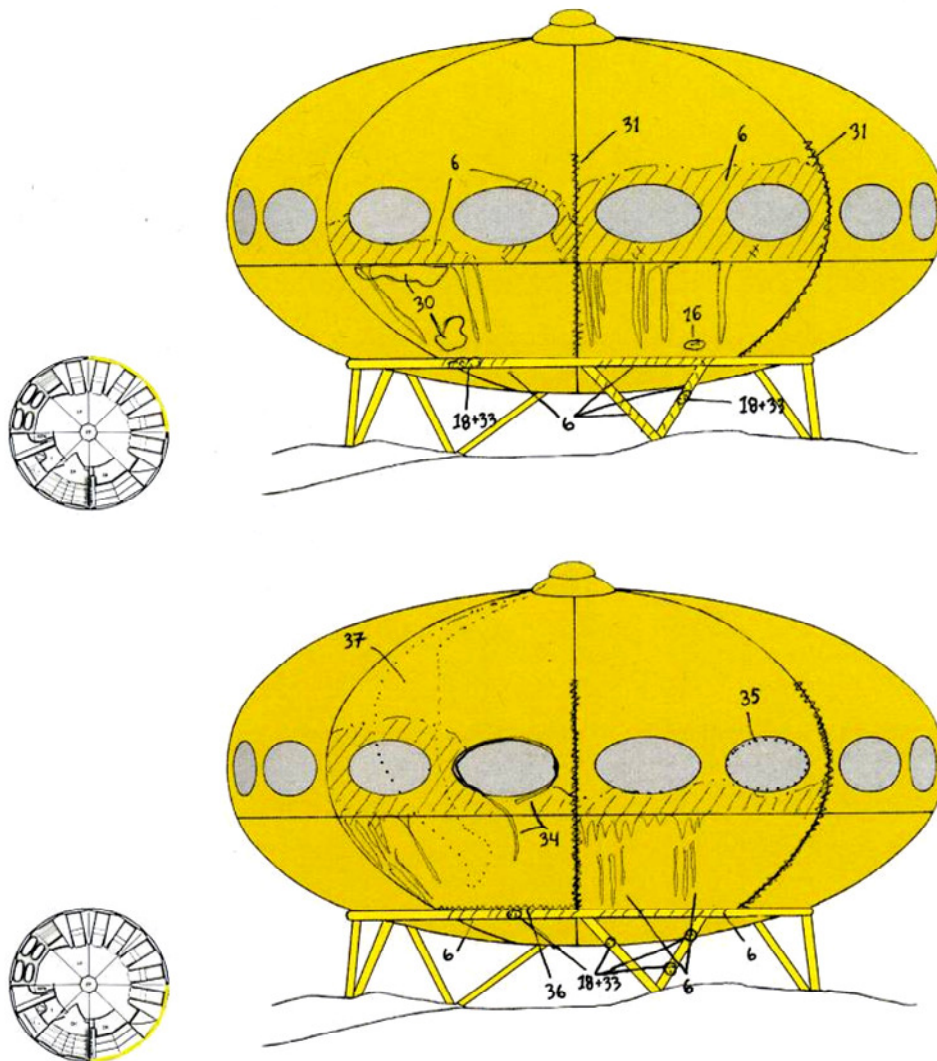
3	Whitish gloom	32	Fracture
6	Black deposit	33	Paint coming off
16	Crack	34	Loose window seal
18	Corroded	35	Missing rubber band
30	Gel-coat become thinner	36	Crumbled plastic foam band
31	Gasket	37	Plastic sheet cover

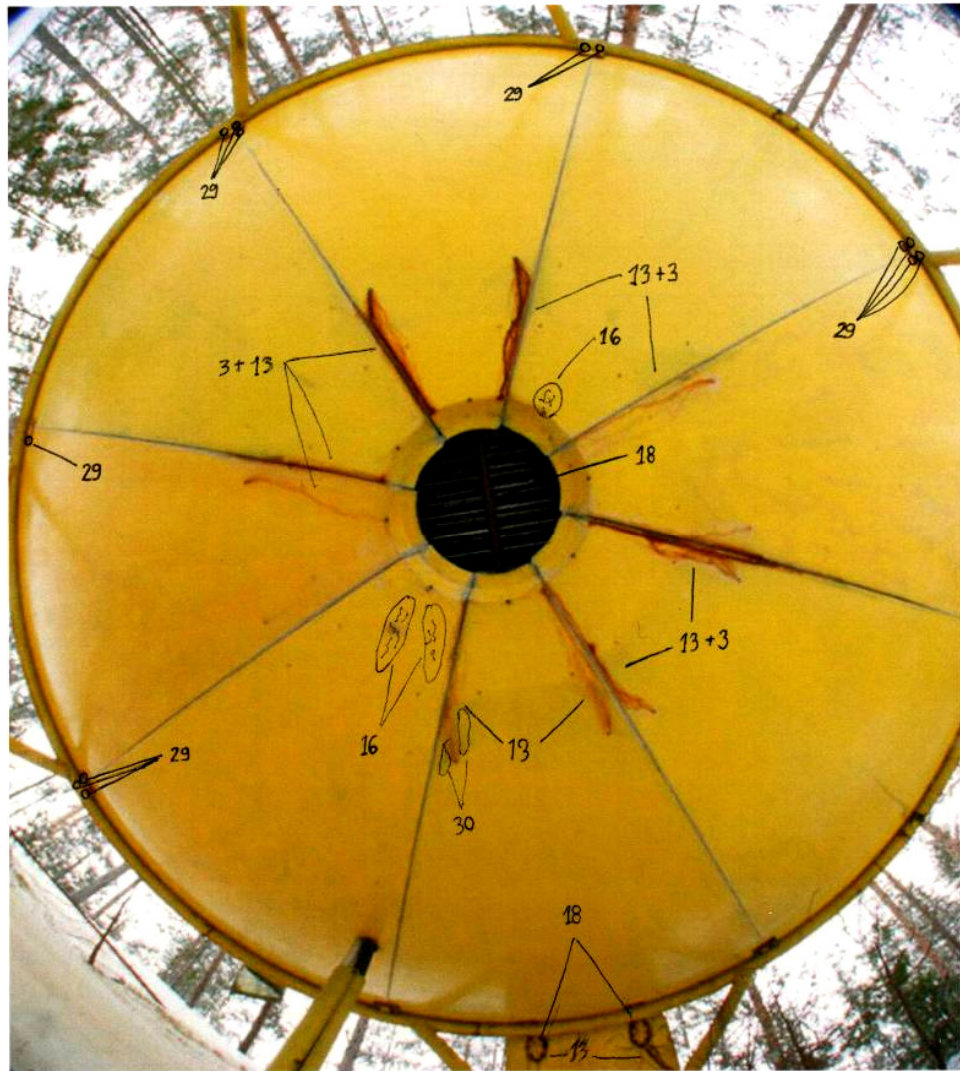
3	Whitish gloom	18	Corroded
13	Rusty stain	29	Missing bolt
16	Crack	30	Gel-coat become thinner

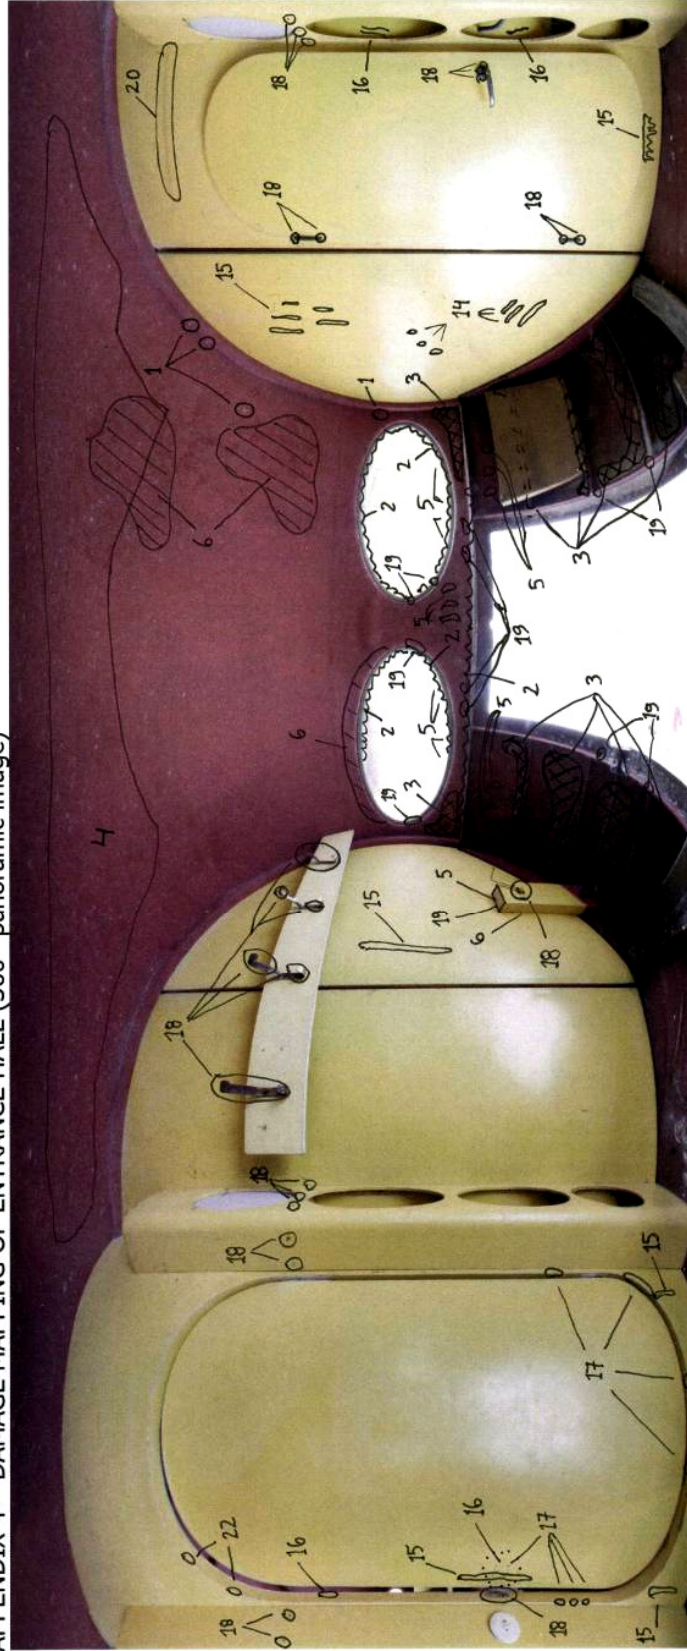
1	Cobwebbed	16	Crack
2	Algae	17	Missing part
3	Whitish gloom	18	Corroded
4	Frost	19	Paint coming off, gel-coat is exposed
5	Bird faeces	20	Elevation of the surface
6	Black deposit	21	Missing Perspex
14	Stain	22	Putty
15	Dirty trickle water stains

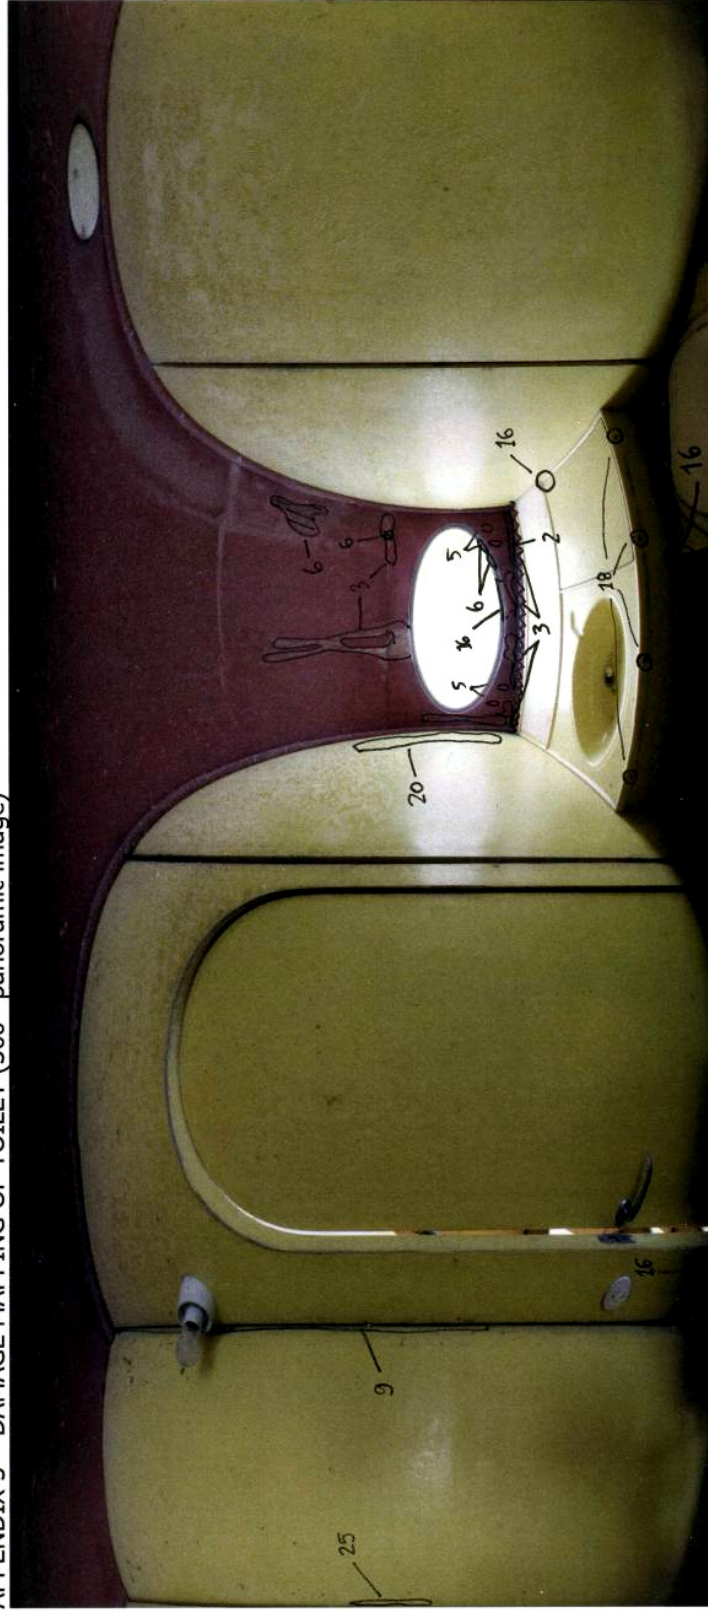
2	Algae	16	Crack
3	Whitish gloom	18	Corroded
5	Bird faeces	20	Elevation of the surface
6	Black deposit	25	A think on the wall
9	White mold

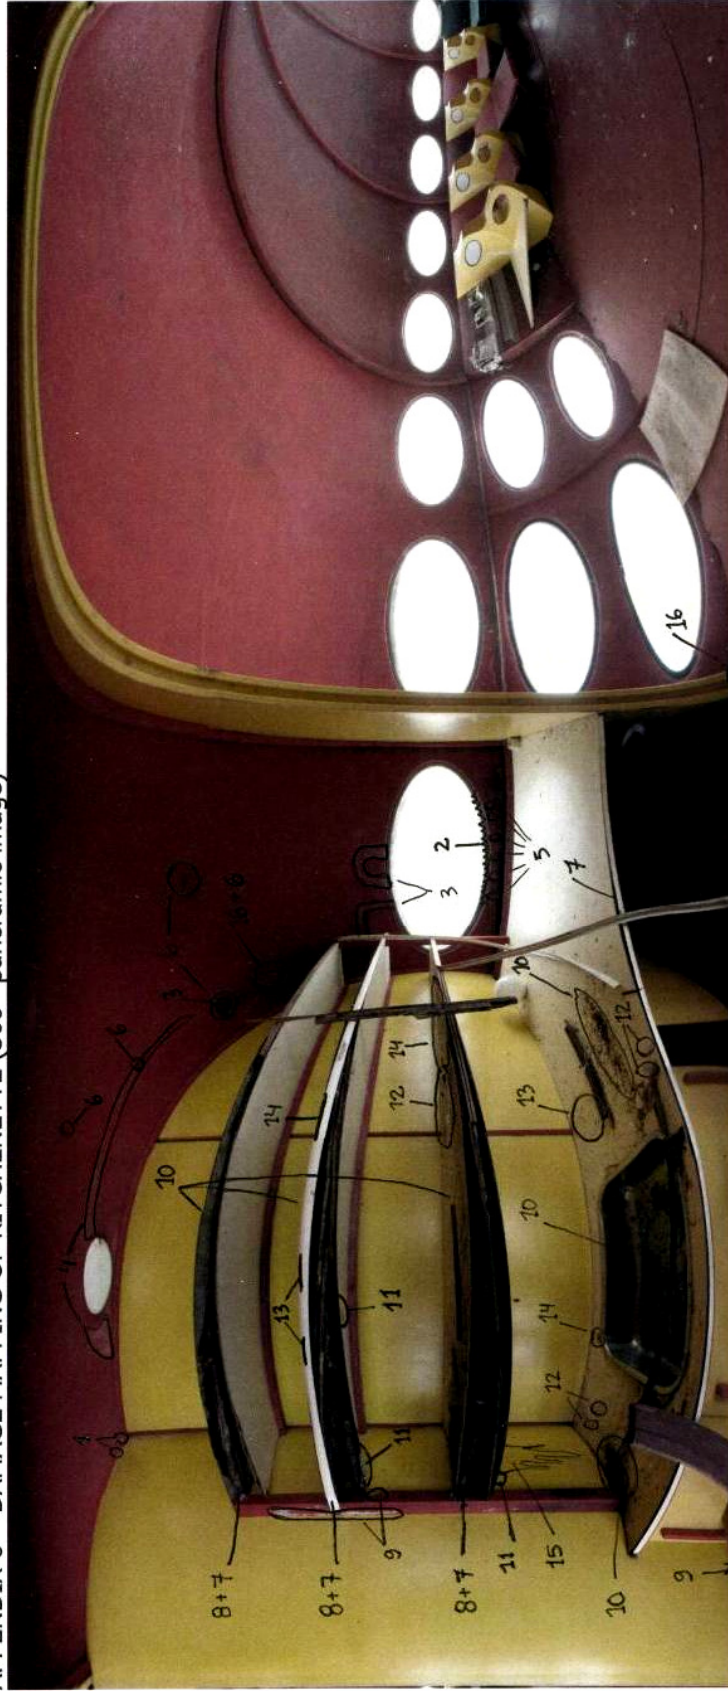
1	Cobwebbed	9	White mold
2	Algae	10	Littered
3	Whitish gloom	11	Moss
4	Frost	12	Paper stuck to surface
5	Bird faeces	13	Rusty stain
6	Black deposit	14	Stain
7	Loose edging strip	15	Dirty trickle water stains
8	Moisten and swollen shelf	16	Crack

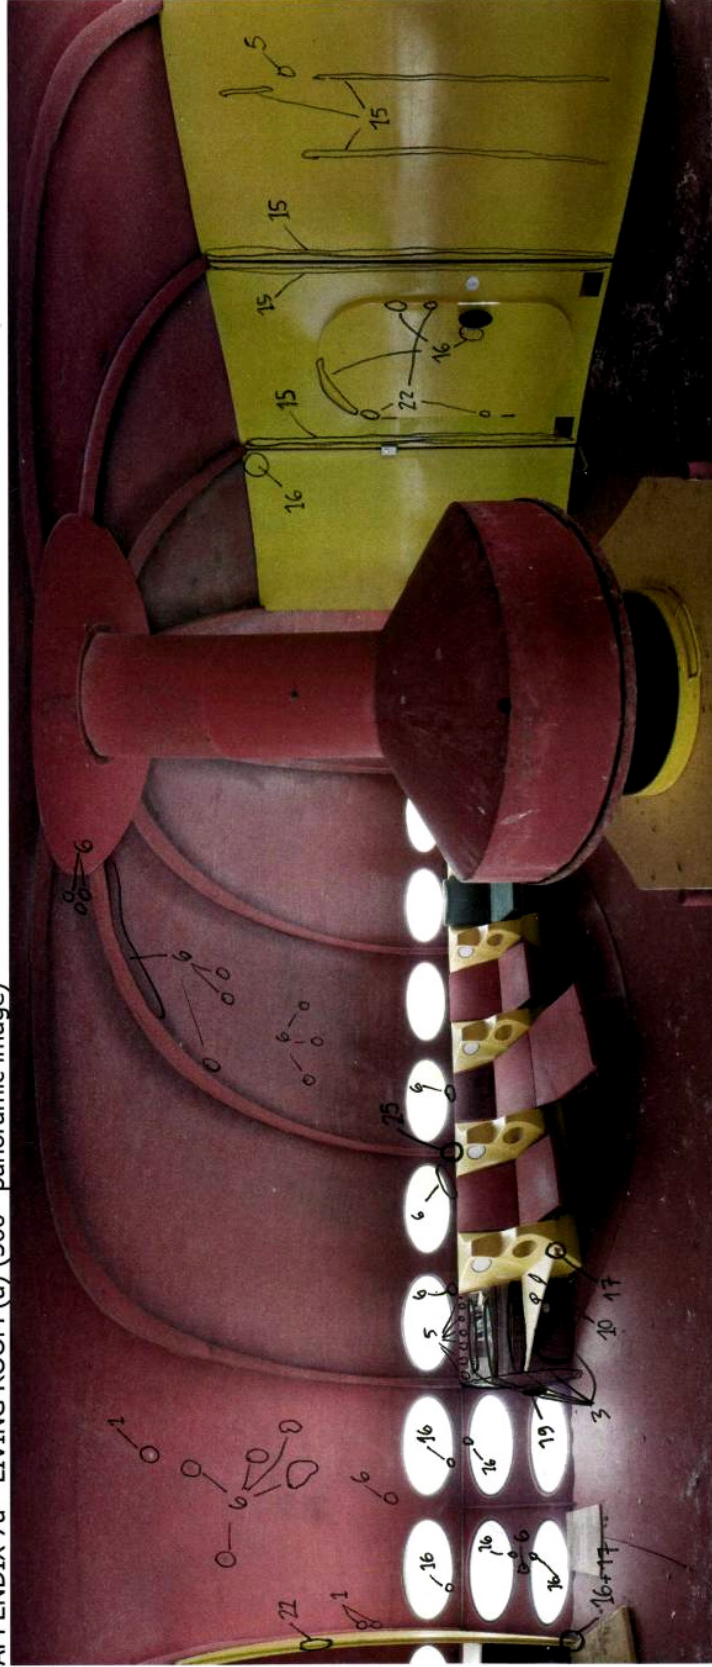
1	Cobwebbed	10	Littered
2	Algae	16	Crack
3	Whitish gloom	17	Missing part
5	Bird faeces	19	Paint coming off, gel-coat is exposed
6	Black deposit	22	Putty

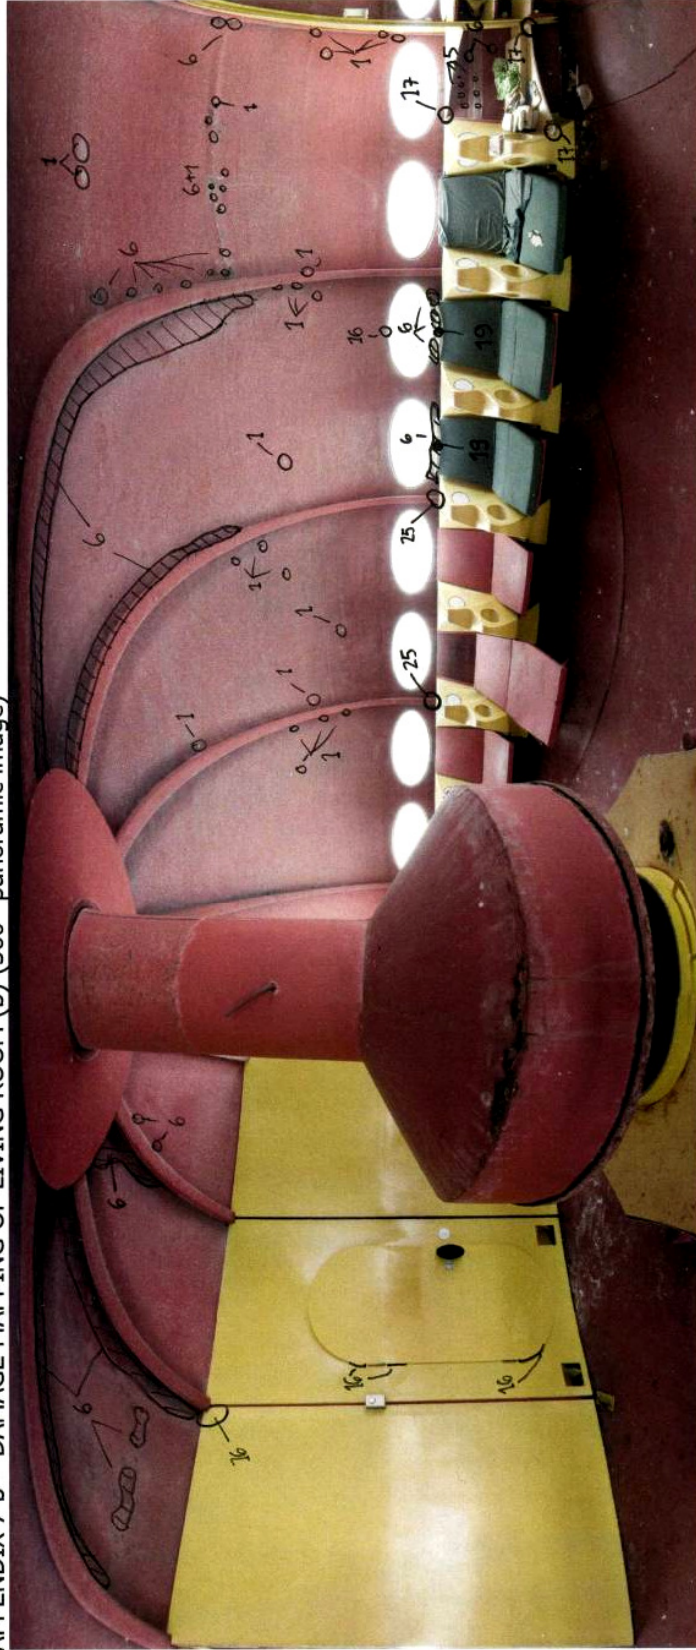
1	Cobwebbed	16	Crack
5	Bird faeces	17	Missing part
6	Black deposit	19	Paint coming off, gel-coat is exposed
10	Littered	25	A chunk on the wall

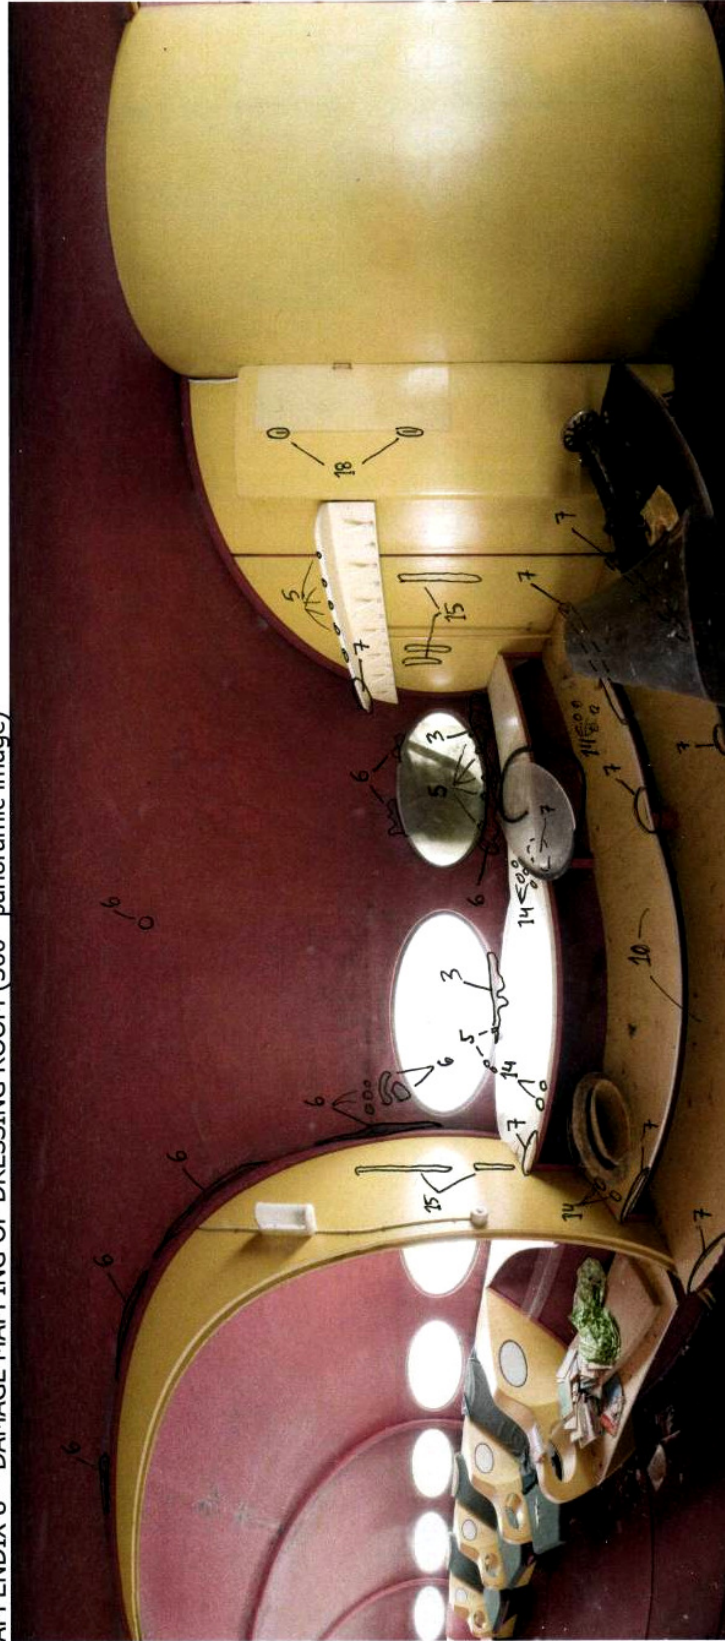
1	Cobwebbed	9	White mold
2	Algae	10	Littered
3	Whitish gloom	14	Stain
5	Bird faeces	15	Dirty trickle water stains
6	Black deposit	17	Missing part
7	Loose edging strip	18	Corroded

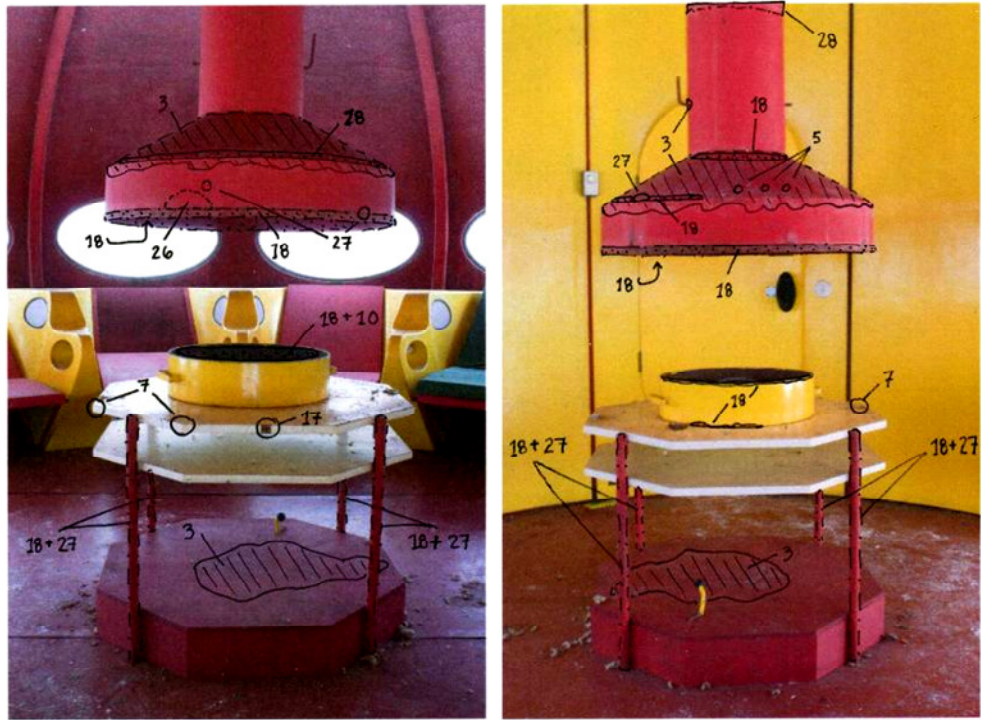
3	Whitish gloom	18	Corroded
5	Bird faeces	26	Bruise
7	Loose edging strip	27	Paint coming off, yellow under paint is exposed
10	Littered	28	Paint flaking off
17	Missing part

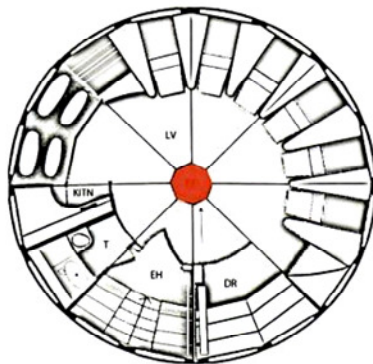
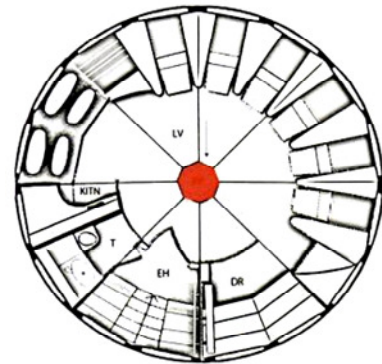
APPENDIX 10 – BORDERS OF THE CARPETS
